Test Report

No. CANMLC2304532903

Sample Name : Acoustic wall panel

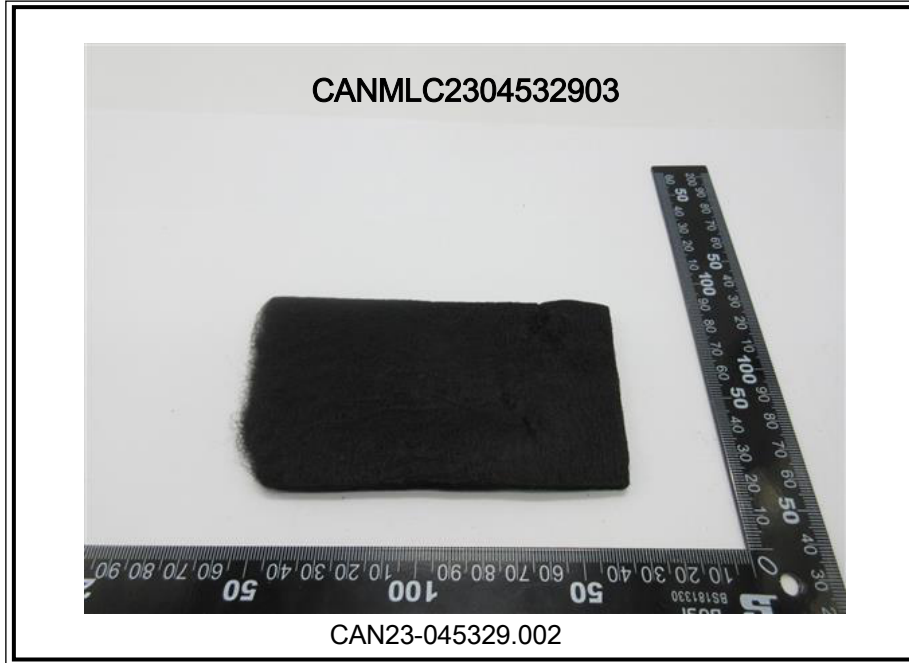
Sample photo:

Specimen No.	SGS Sample ID	Description
SN1	CAN23-045329.002	Black soft material
